# Suitability of Steel

## The Critics Are Out There Against Light Gage Steel Framing—But The System Has Stood The Test of Time

By Richard N. Parker  
The Bostwick Company

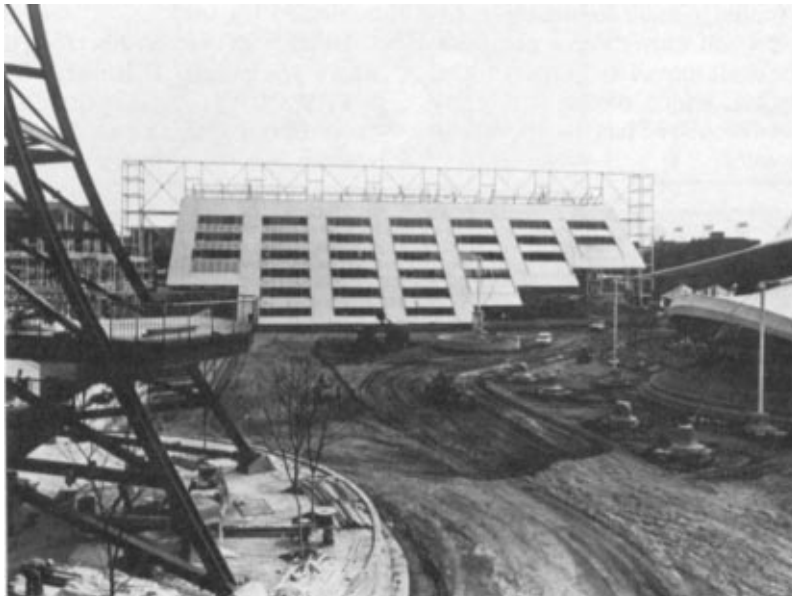
Both the Sunsphere (left foreground) and the US. Pavilion (background) have steel studs.

did not occur at the 1982 World’s Fair in Knoxville, TN, but Light Gage Steel Framing was there in force. Although most foreign exhibits are housed in basic “metal buildings,” many facades and most interiors were fashioned from steel studs and joists. Studs are suspended, cantilevered or seated on floors and foundations. They stand vertically, lay horizontally and create many angles, as in the Korean Pavilion (q.v.). Buildings with unusual shapes such as the U.S. Pavilion (shown) used steel studs and joists.

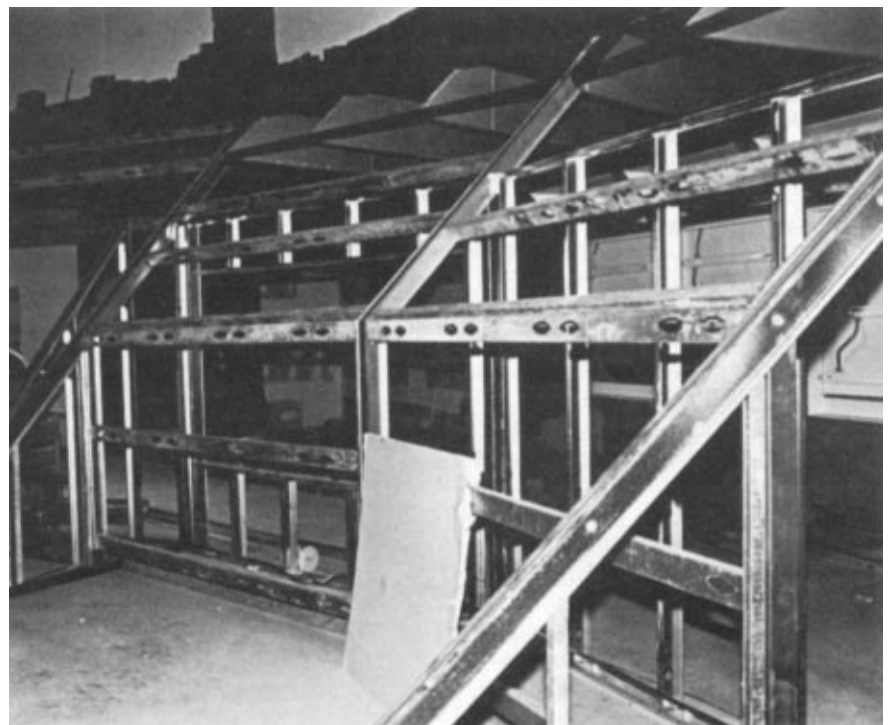
Korean Artifacts will be displayed on shelves and cases supported by L.G.S.F.

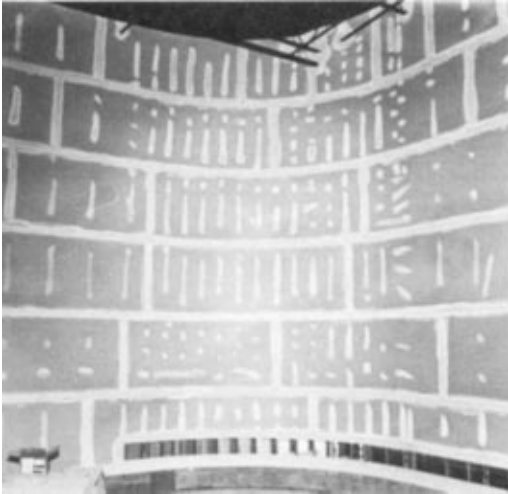
A tall backdrop of studs and board for a mockup of the Gulf of Mexico. Oil drilling rigs will follow.
