Primers Beneath Fire-Resistant Coatings

by Douglas Jones, Southern Coatings, Inc.

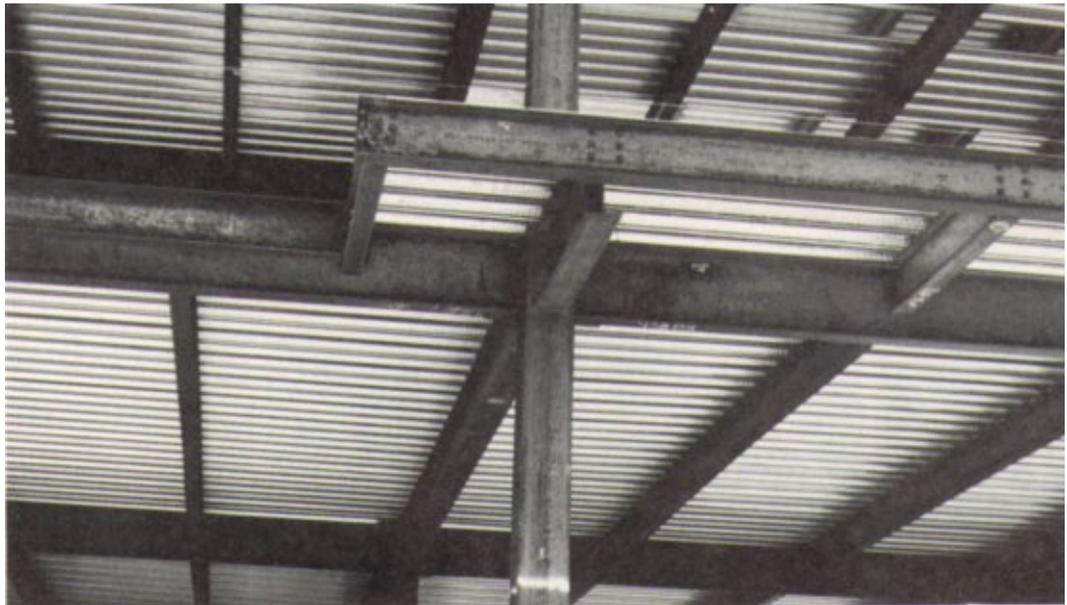
Fig. 1

Active rusting and damaged mill scale on structural steel immediately before fireproofing

No matter what the conditions of storage, weather, contamination, or jobsite delay, they tend not to be predictable, and therefore planning on the basis of worst case scenarios is in order. Figure 1-3 show the results of some of these conditions.

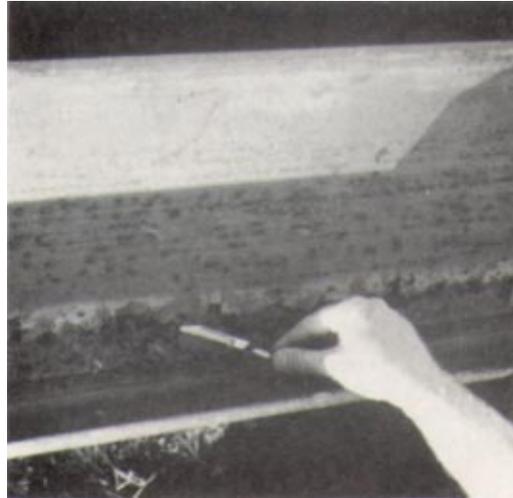
Fig. 2

(top) Fabricated steel has slivers that, without blast cleaning, will become sites for rusting.

(bottom) Corrosion on a beam in a fabricator's storage yard prior to shipment to the job site.

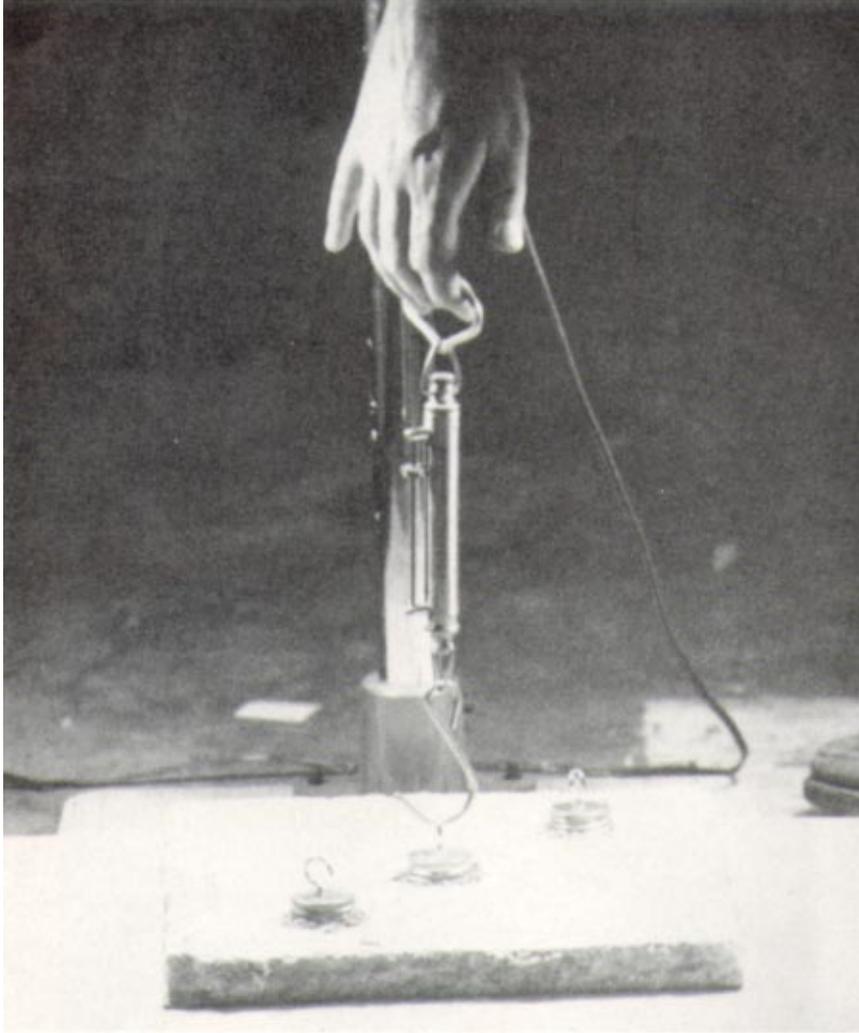
Fig.4

*Pull test measures
adhesion of
cementitious, spray-
applied fireproofing.*

This procedure sets forth a method for determining the amount of force necessary to remove fireproofing material from a surface.

3.2 After 28 days, a 1¼ in. metal cap with cup hook (cap is made by inserting a threaded cup hook in the center of the cap from the outside and a small piece of wood is attached to the threaded end of the hook—so that the hook will not be pulled out). This assembly is glued near the center of the panel with epoxy glue made of 1501-AR Polyam, Hardener 37-615/1502-AR Epotuf 38-501 in a 35-65 non-volatile weight ratio. This is allowed to set up 48 hours minimum. A scale with ¼ in. increments to 30 lbs. maximum is pulled and held for one (1) minute unless failure occurs at lower weights.

3.3 Calculation: the pounds of force necessary for failure is divided by the area of the cap in sq. ft. Force required for failure is then reported in lbs/sq. ft.

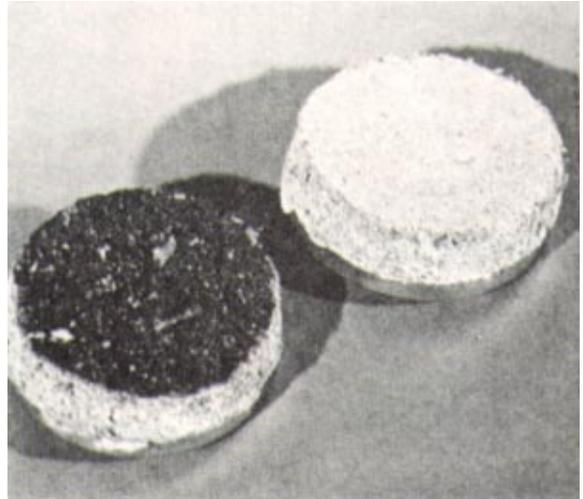
Fig. 5

Fireproofing material above has been pulled from the substrate for an adhesion test. Plug on the left, applied to bare steel, shows rust stain; adhesion measured 94 lbs/sq. ft. On the right, plug was removed from surface primed with zinc chromate adhesion measured 302 lbs/sq. ft.

Results of the tests demonstrate that selected metal primers afford higher bonding strength than is obtained when the fireproofing is applied directly to unprimed steel. Figure 5 shows two samples of this test. The disc on the right, with the light surface, was applied to steel primed with a zinc chromate primer and produced a bonding strength of 302 lbs/sq. ft. The disc on the left, with the dark surface of heavy

rust stains, was applied to bare steel and produced a bonding strength of only 94 lbs/sq. ft.
