TWENTY-THREE MILES OF CAULK

The Washington Temple of the Church of Jesus Christ of Latter-Day Saints is undergoing a \$2 million renovation. Plans to restore the Kensington, Md. structure began nearly two years ago with an exterior conservation appraisal conducted by Harty Weese Associates. The comprehensive study included a detailed examination and evaluation of the 11,800 Alabama white marble panels (173,000 square feet) sheathing the 16-story temple.

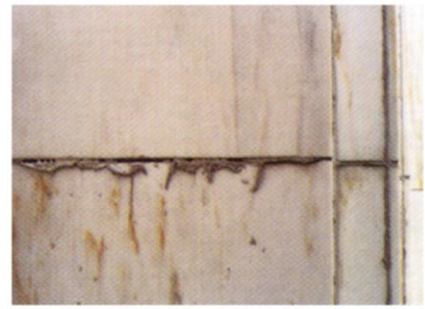
Deteriorated sealant has softened and melted out of horizontal joints. Photo by Kathy B. Sedgwick.

The original caulk had softened and moved out of the joints, and in some cases the caulk ran the full length of vertical joints to create a gooey pool at the building's base.

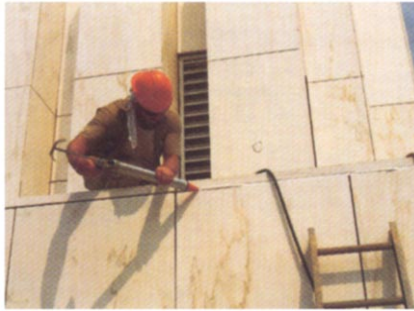
Bruce Carter (Pagliaro Brothers) adds new caulk to a horizontal joint on one of the six towers. Photo by Kathy B. Sedgwick

During the renovation, the old caulk is being removed with electric blades. A new backer rod is installed at each marble facing joint. At each vertical concrete panel joint both a primary and secondary backer rod are added, with a weep gutter to the exterior.

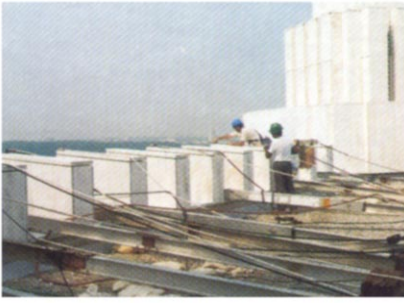
Workers check safety lines on the rooftop. Note the beams that counter balance the tow-man baskets, which are lowered between fin walls.

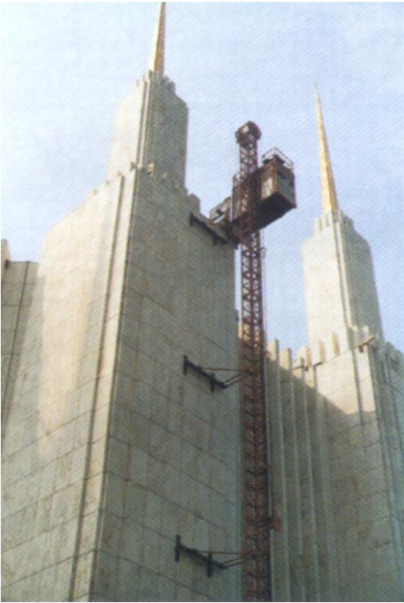
The hoist tower had to fit into a very narrow gap in the side of the building.

The shape of the structure also created some complications. The hoist tower had to fit into a very narrow gap in the side of the building. This limited the space available into which to put the ties to hold the machine. UBS designed a fabricated special tie that holds the hoist tower to the building.

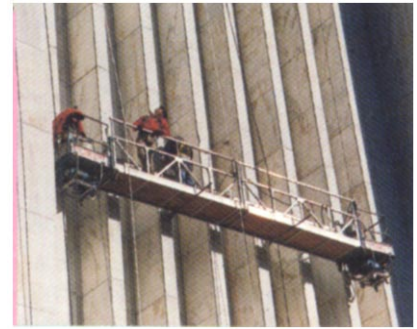
Narrow “fin” walls complicated the job. On the left a small “basket” rides beside a modular platform rigged to work outside the fins. Photo by Christopher Bates.

series of narrow, fin-like projections. The “fins” are about 35 inches deep, with spaces between them ranging between 32 and 36 inches. Workers and equipment must fit between the fins and still have room to work on the marble panels on all three sides.

Modular scaffold platforms were used across the face of the fins, with traction

hoist “baskets” fitting between the fins.

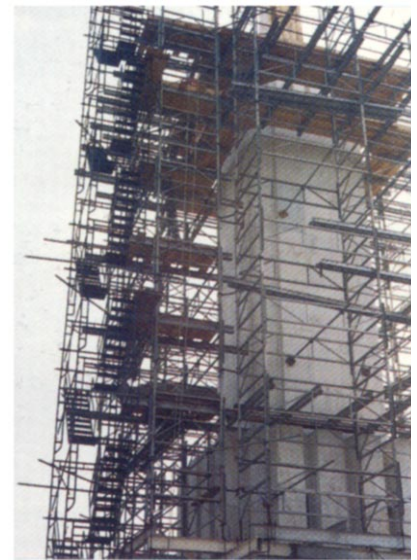
Scaffolding on one of the six towers rises from the roof to the base of the gold-plated spire. Photo by Kathy B. Sedgwick.

The newly approved work on the tower above the roof could have created some logistical problems. UBS resolved potential problems by providing two towers’ worth of material. “While they work on one lower, we erect the second,” said O’Callaghan. “When the work is complete on the first tower, they move to the second, which give us time to break down the first and put it up on another tower, and so on until all six towers are complete.
