Getting the Most From Steel

There's Little That Steel Can't Do in Modern Construction—
And Steel and Brick Make a Fine Combination

By Bill Leach
Bostwick Steel Framing Company

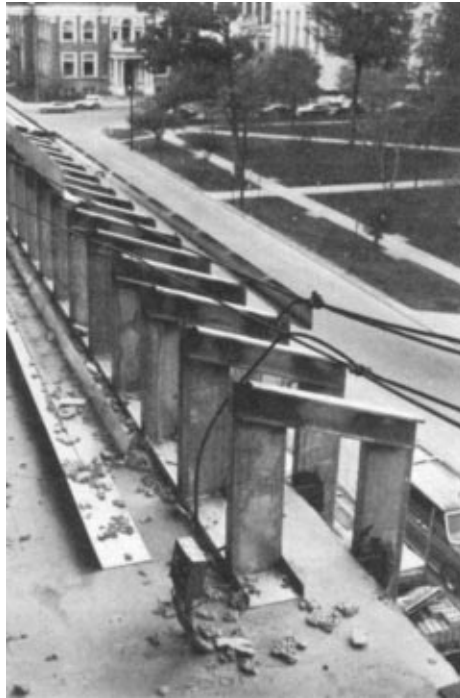
A close-up of the inverted “J” framing sections on the fourth floor of the Erie Insurance Group building. Light gage steel track was power-fastened to the slab, and then the short end of the “J” section was placed in it. Erie Acoustical fabricated “J” sections from 4” and 6” Cee Studs.

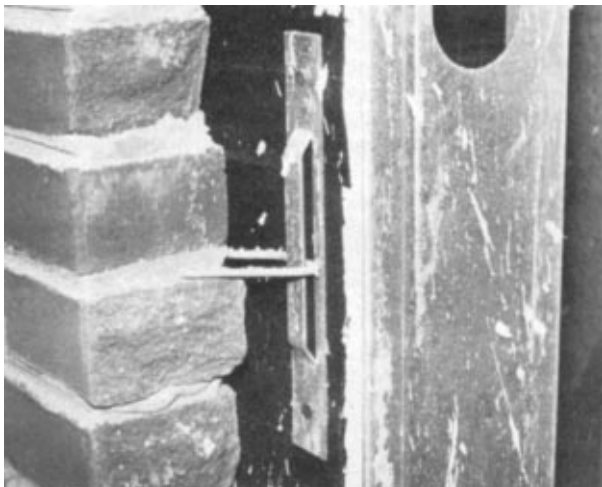
Masonry workers used screws to attach DW-10 adjustable brick ties to the 14 gage Cee Studs through the ½" gypsum sheathing.
