Desert Water Holes: Material Know-How Pays Off

A Contractor's Experience Helped Provide an Adequate
Water Supply for Arizona's Bighorn Sheep

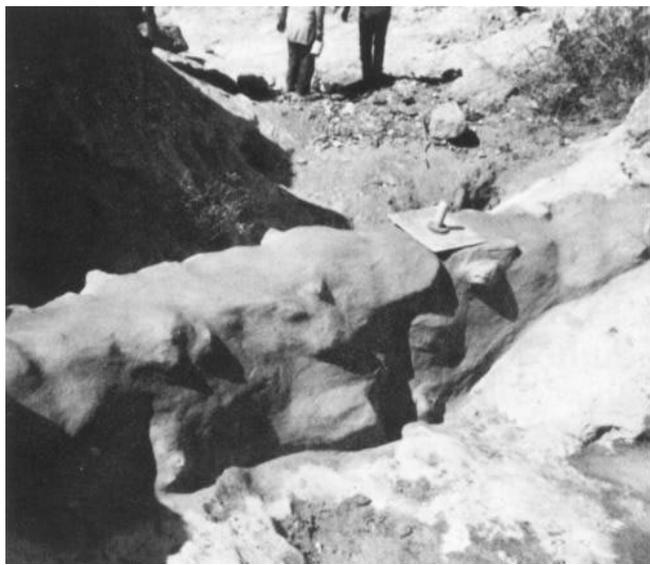
BEFORE — This is the clay bottomed Black Bottom water pot hole near Gila Bend, Ariz., that was sealed and waterproofed with Thoroseal and Acryl 60 in a team effort led by Bob Gray, of Gray Plastering, Phoenix, Ariz.

His answer: use Luminite (TM by U.S. Steel Corp.) to accelerate the setting time of the cement used in building the dam, and then waterproof the natural setting with Thoroseal, using Acryl 60 as a bonding agent.

cement earned for itself a place in history when the dam makers named the 1972 Black Bottom Pot Hole after the black color that used to characterize Calcium Aluminated Cement. This pot hole is located in the Saucedo Mountains near Gila Bend, Arizona.

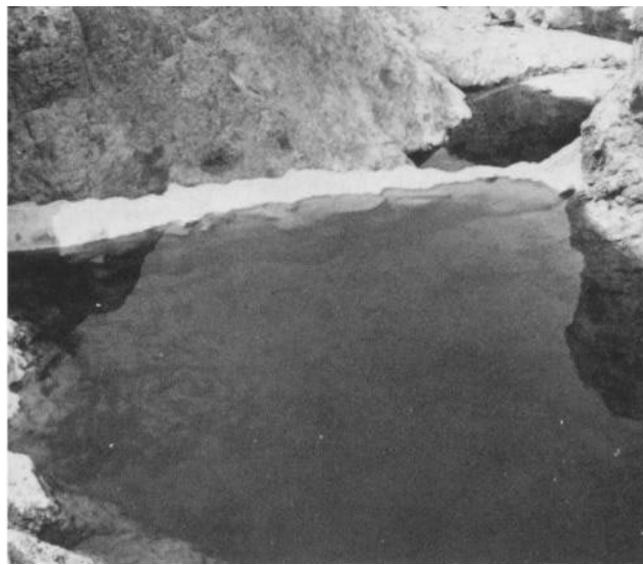
AFTER — This is the same Black Bottom pot hole filled with rain water and ready for use by Arizona's desert bighorn sheep. The pot hole was named after the Luminite used to accelerate setting up time of cement.
