Off Comes the Asbestos

Removing Old Asbestos is a Nasty, Dirty Job and It' Must Be Approached Carefully, Expertly

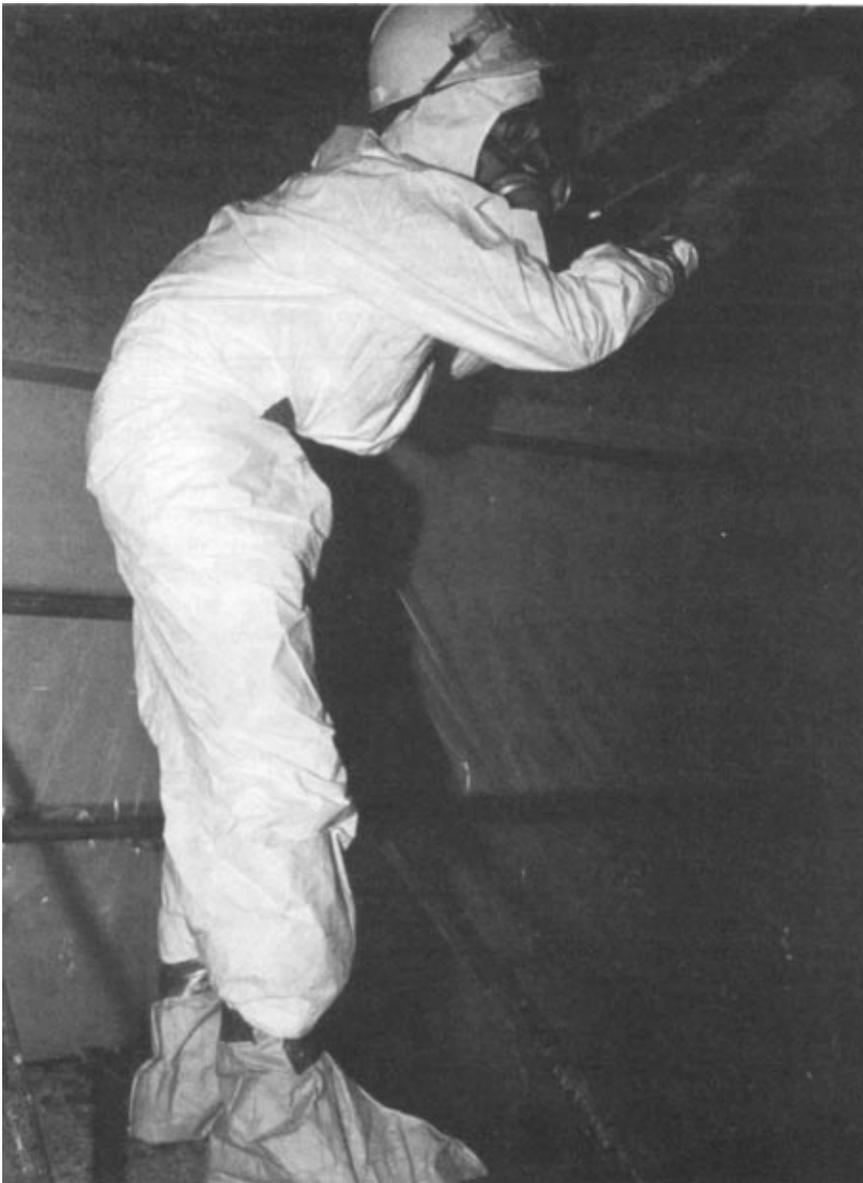
Dunseath construction workers were protected from asbestos fibers and dust with disposable clothing which included coveralls, hoods, and shoe covers.

In addition, workers were fitted with special respirators and protective clothing, including disposable, full-body suits, hoods, and shoe covers.

The special man-made fabric has a high tensile strength and is tear resistant. Such features are important in rugged construction areas. It also provides protection from asbestos particles and fibers down to 0.5 micron.

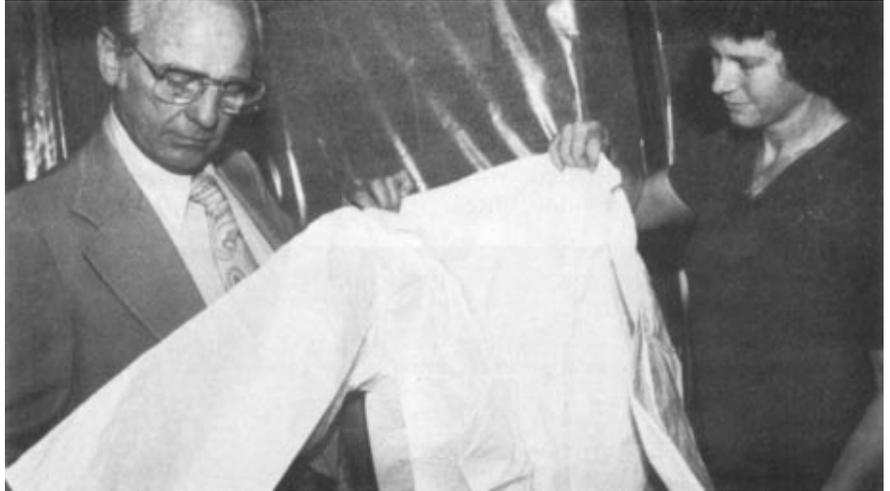
Disposable garments of "Tyvek" are inspected by Leroy W. Moore, director of physical plant for the independent school district #707 in Duluth, Minn., and Heather Dunsheath, contractor for the asbestos removal project at Duluth Central High School.

In contrast, the garments of DuPont’s “Tyvek” were disposed of whenever a worker took a break. “Every time a worker took a break, he had to decontaminate, which included showering and donning a new outfit. Generally, the workers did this two or three times a day,” said Dunsheath.

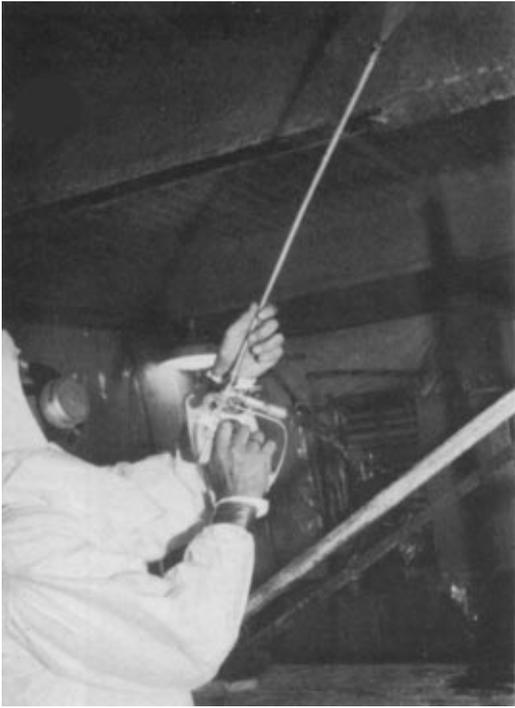
Before scraping operations began, water and a special wetting agent were sprayed on the asbestos to help minimize the asbestos fibers and dust which could be in the air in the sealed off work areas.

Before actual removal, the asbestos was wet with water and a special wetting agent to help contain the fibers. “Humidity is also a natural dust controller,” Dunsheath explained.

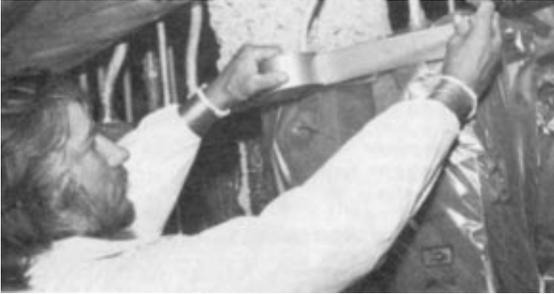
Worker seals electrical circuits with plastic and duct tape prior to spraying the asbestos to be removed. Such precautionary measures minimized potential problems

Every work area where asbestos was removed was sealed like a cocoon. Everything was covered with polyethylene sheets except for the actual areas where asbestos was being removed. Barriers were made of overlapping sheets of plastic. These sealed off both entrances to each work area. An air filtration system on one side of the barrier used fans to draw the air through special filters to remove particles as small as 0.3 micron. Dunsheath said that the system has HEPA filters and all air moves through these filters, making it 99.97 percent efficient.
